### DAMAGE DUE TO STRANDING

Vessel name:	Melody

Registered port:	St John, USVI	
Assured:	Martin Andersson	
Hull identification number:	CAT47120B000	
Vessel description:	2000 model Catana 471 FRP sloop rigged catamaran with twin auxiliary diesel engines. Approximate dimensions 47'L x 25'B x 5'D (measurements not taken).	
Policy #:	CSRYP/172119	
Status:	Recommended to Underwriters as a Constructive Total Loss pending coverage.

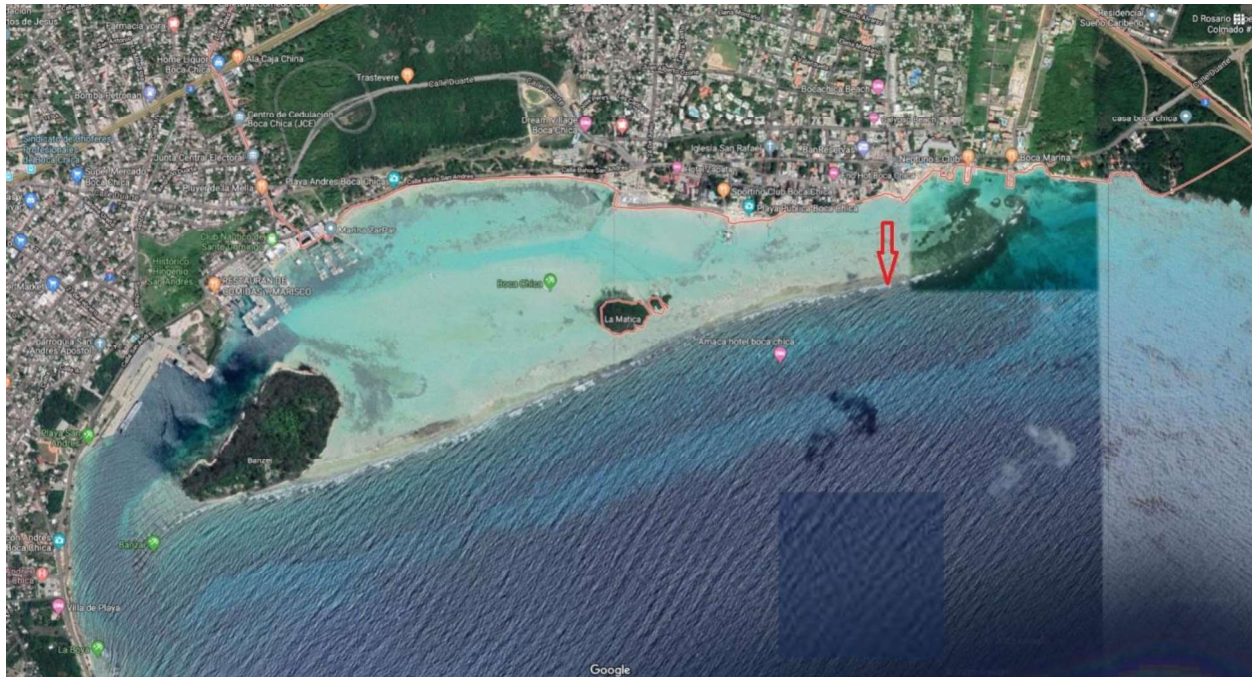
Satellite view of breakwater. Red arrow denoting approximate location of stranded vessel. The entrance to the harbor is on the far left.

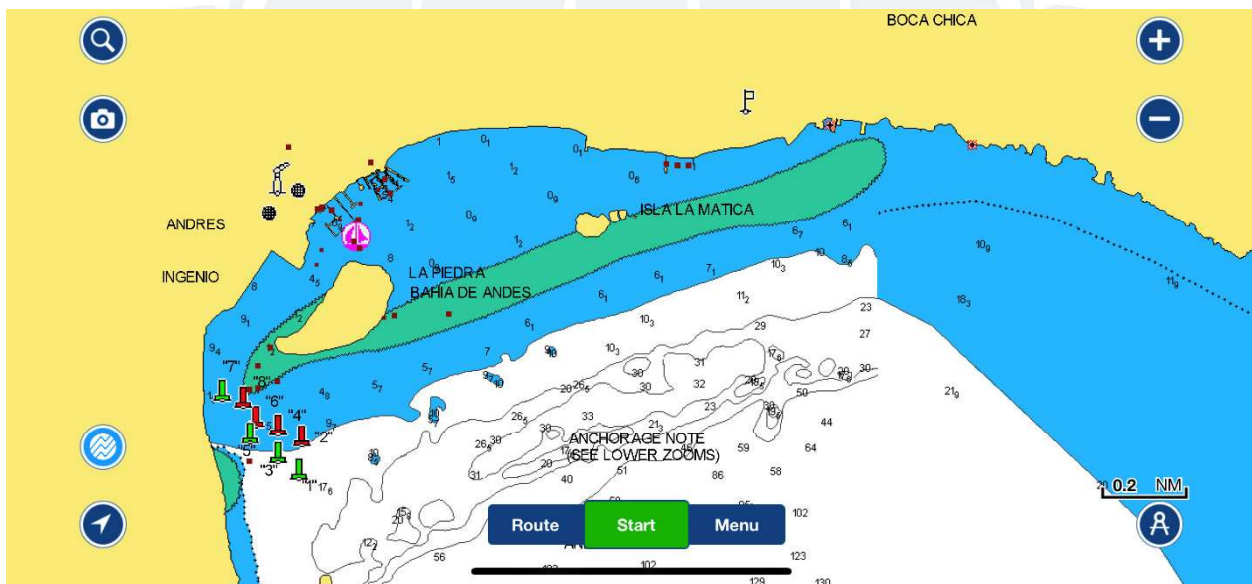
Breakwater shown on the latest Navionics chart data

The area of most concern with regards to potential seaworthiness is the procedure into a port in the dark with no local paper charts, no local cruising guide, no local knowledge, and what appear to be either defective, outdated, or absent electronic charts. The Master reports that the breakwater did not show up on the Raymarine Chartplotter. However, we have compared both current Raymarine charts and ones that are over two years old. The breakwater is clearly shown on both, as well as the entrance and marks to the harbour. We have asked that salvors take possession of the GPS unit and send it to us for further testing and determination of this fact.

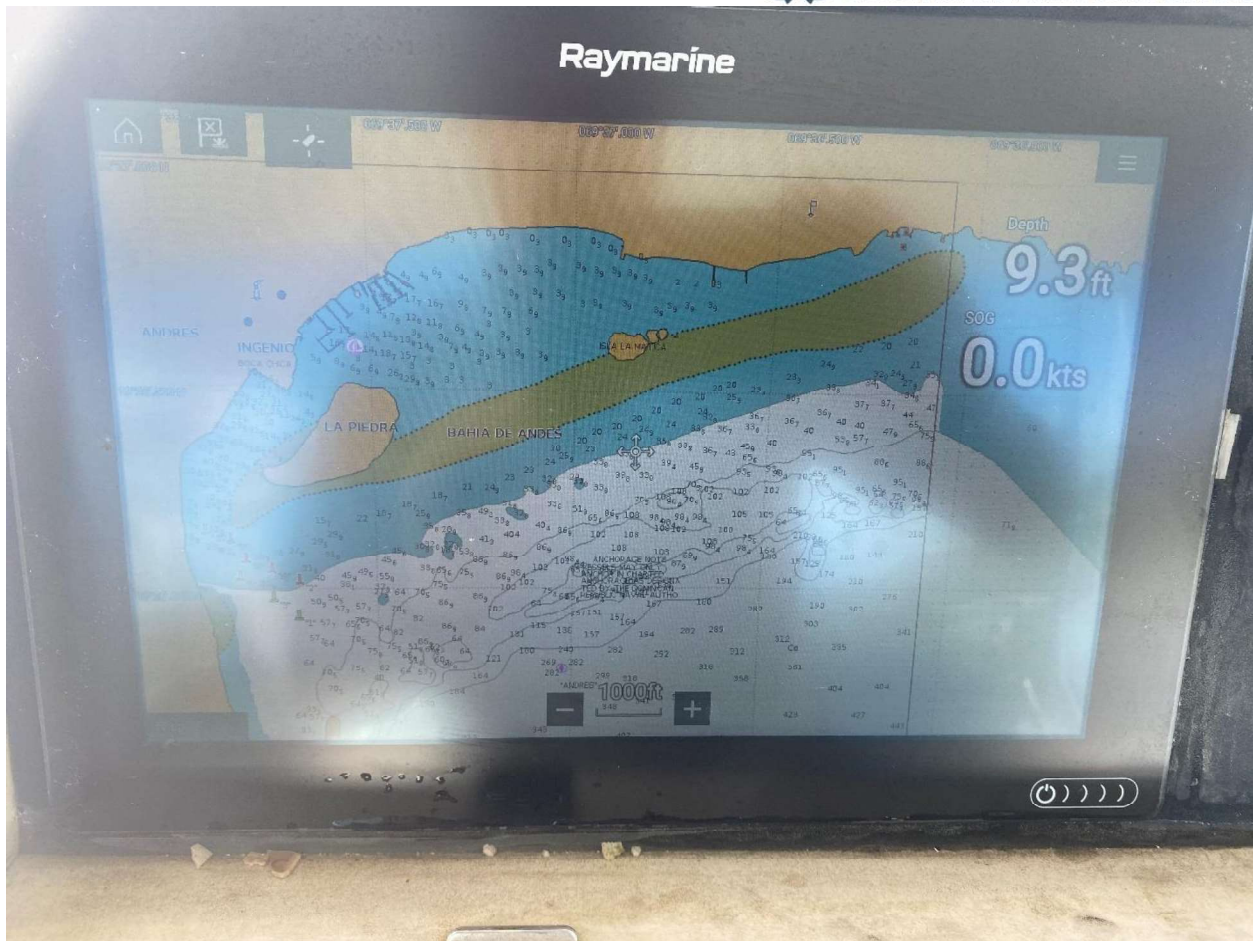
>2 year old chart data taken from our company vessel.

The breakwater is unlit at night.
